Corwen Central News

Necessary Repairs

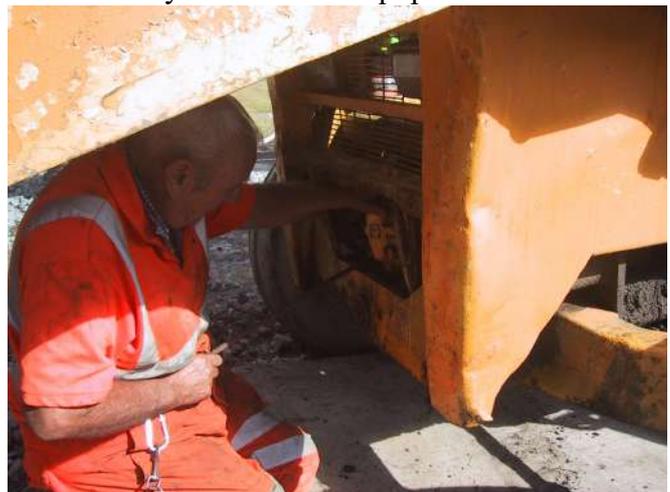
John Mason encouraging the hydraulic pump to be seated

together by lots of “wings” and “prayers” and a lot of basic maintenance. Unfortunately whilst working on the site the JCB MkIIC had its main hydraulic pump drive shaft fail. This left the machine “high and dry” with no way of moving. Subsequently it was lifted out of harms way by the REXQUOTE/CASE road-railer.

Thankfully replacement parts are still available for the JCB and were soon on site to enable repairs to take place. The down side for this is what appears

to be a straightforward task usually turns into something more complex. However, after much crawling underneath and looking down through the engine compartment Peter Robson and John Mason got the new parts to where they were designed to go. The JCB was subsequently used to move the newly arrived ballast from Bonwm Farm to the cross over site.

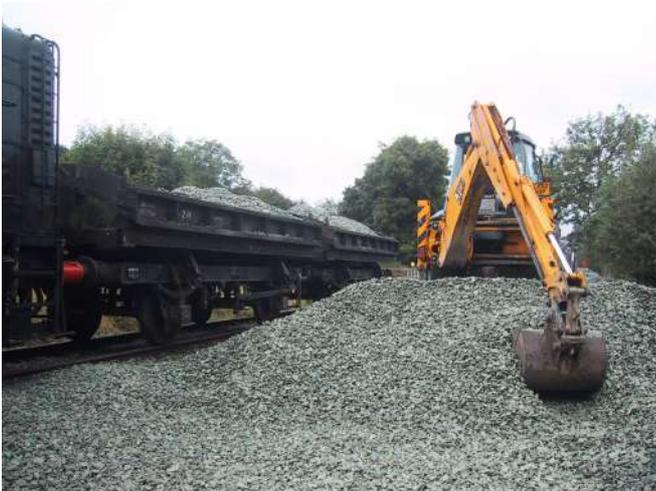
Loading the Mermaids at Bonwm Farm Photo : PR

bring down ballast to spread on the site of the crossover. A recent survey of the site showed that the drop on the track was at least 45 cm so this needed to be built up to allow for the correct levelling of the crossover timbers and give an up grade of about 1:500 entering the down platform. Photographs show Arwel Dolben loading the Mermaids at Bonwm and their subsequent unloading at Corwen. A track extension to the

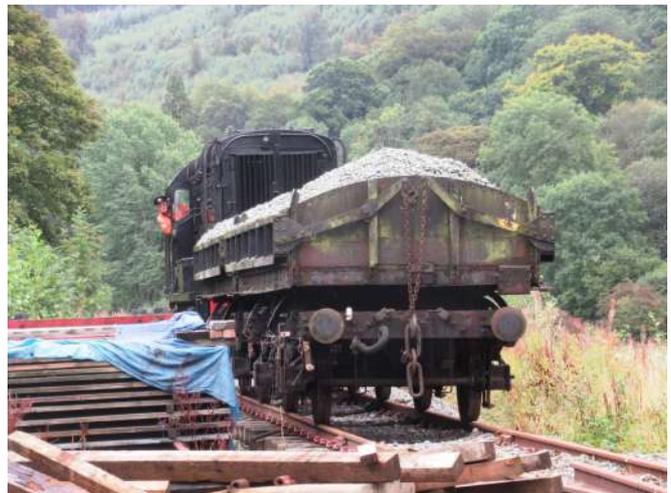
*Mermaids arrive at Corwen in charge of the 08 shunter
Photo: GJ*

At the end of the day's work eight wagon loads were delivered to Corwen amounting to about 120 tons of ballast. Track engineer, Peter Jump said he was more than satisfied with the amount of ballast now on site. He said that there were no more full track panels to go in as far as the main line was

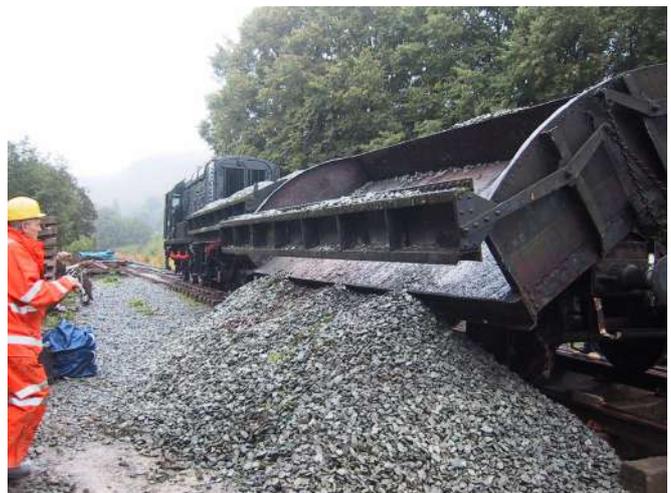
Emptying the first load of ballast at Corwen

The extra panel recently laid (on which the ballast wagons were unloaded) will be more or less where the point starts which is 33 metres long plus twist rails either end of it which will add about another 15 metres. Peter is hopeful that work will start in laying out the points quite soon.

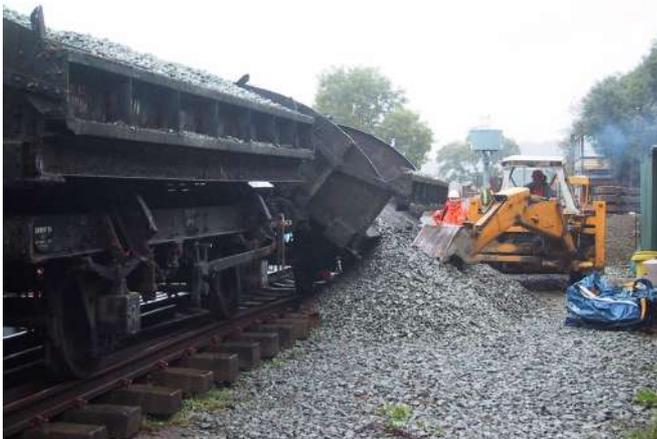
Repaired JCB helping to clear the ballast from tipping site
Photo : PR

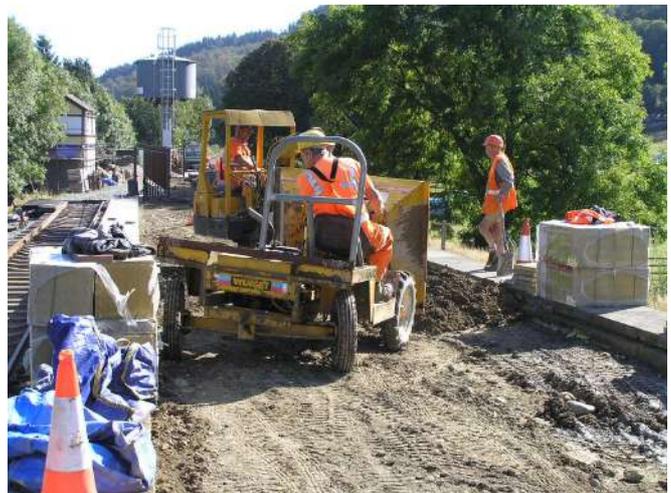
Tipping infill at the East end. Mini digger grading-
in
Photo : PR

the confines of the underpass exit to the platform and to the east end near to the water column.

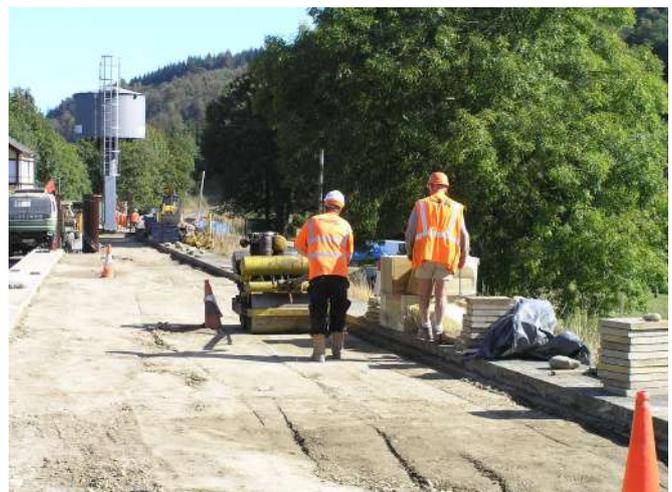
Taking advantage of a recent dry spell, infill has been moved from the Ruthin Spur up onto the platform. The main drainage points have been put along the length of the platform so it is now possible to bring the platform base up to the level required for block paving. The Project's own *Winget* dumper was put on delivery duties to the wide parts of the platform whilst a “narrow

Rolling and compacting the platform surface after the infill drop
Photo : PR

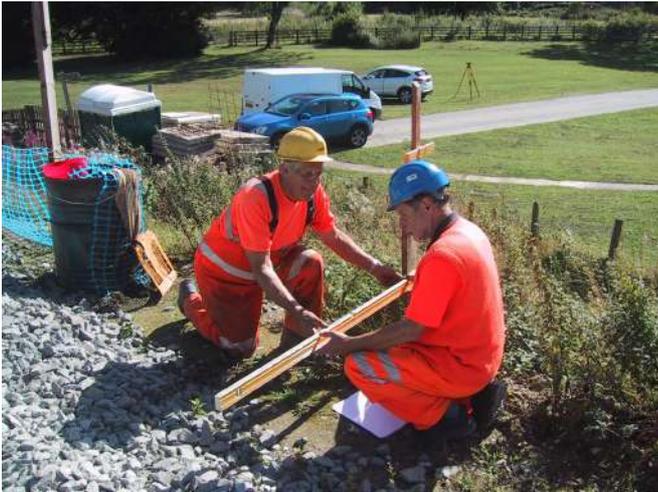
Paul Whitton and Peter Neve check the ballast level using a pre-surveyed datum point Photo: PR

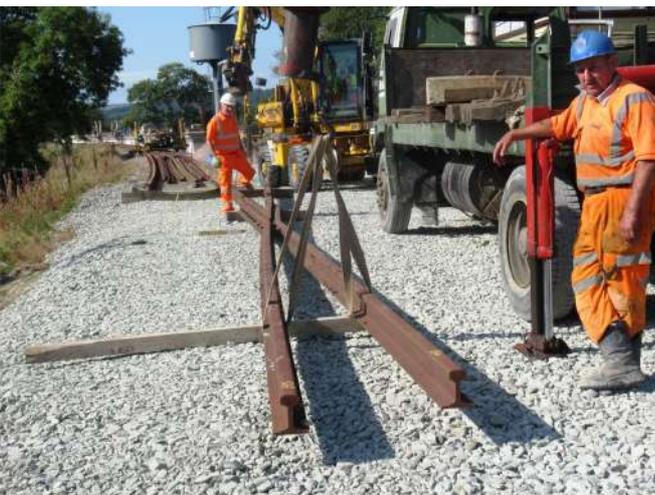
The photograph shows the right hand part of the point leading over to the right hand side of the track in Platform 1.

Trial positioning of crossover component

Needless to say there is much more to be done, but there is nothing wrong with the track gang becoming familiar with the component parts and their positioning in readiness for the addition of the bearing timbers (sleepers).

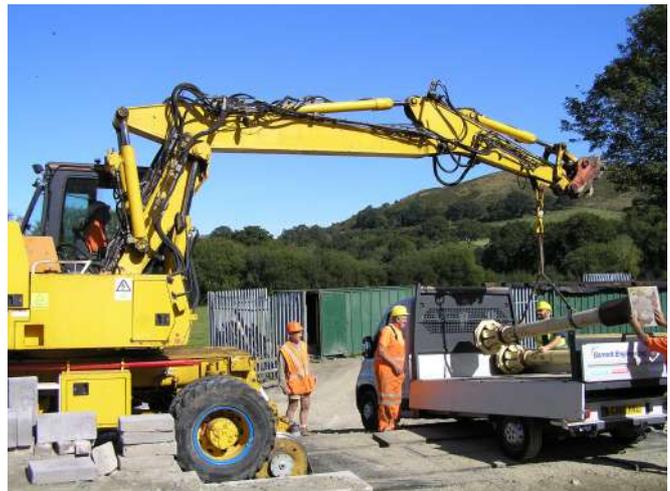
Having received the canopy columns back on site a couple of months ago, they have now to return to Barnett Engineering to have some additional brackets welded to the top in order to carry more bracing steel. These extra items are as a result of the redesign carried out by the Project's consulting engineers (see *CCNL passim*)

Blackfriars columns being loaded for return to Barnett Engineering Photo : PR

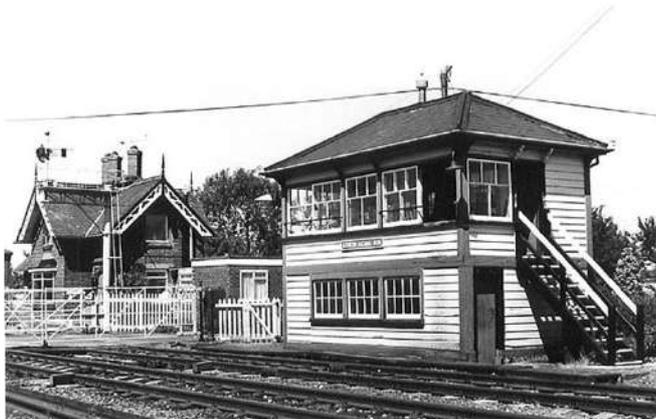
Leaton Signal Box in the 1960s with station to the left Photo : The John Mann Collection

The box originally came from Leaton, a station on the Chester to Shrewsbury line. It was moved to Llangollen soon after its closure in 1987. Like most of the infrastructure along the line, the Glyn signal box has been on the receiving end of all the weather that Dee Valley could throw at it, until the loss of several slates produced a leaking roof, that simply could not be ignored!!

Thankfully the weather was mostly favourable for the roofing work which involved removing broken slates and carefully stacking the good ones ready for restoring to their rightful position on the newly placed roofing underlay and support battens.

Whilst the roofing activities were taking place, damaged facing timbers were replaced and the front of the box was painted in GWR colours of chocolate and cream – but only to “waist” height. For those readers who are unfamiliar with Glyndyfrdwy signal box – it is of all timber construction, (unlike others on the Llangollen railway which have a brick built base with a timber operating floor) and susceptible to damage around the base and side timbers.

Work will continue now that slates have been replaced on the side facing the track, access being gained via scaffolding at the rear. Painting and other renovation work can continue using portable platforms and ladders.

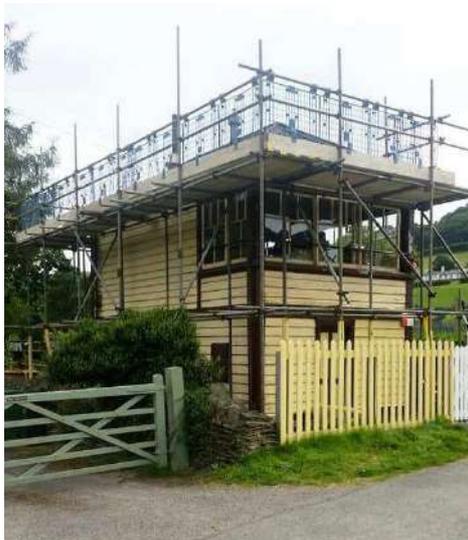
Scaffold in place - back view looking north Photo : PC

The difficulty with such work is that scaffolding needed to be erected all around the signal box, fouling the main line in the UP direction. Thus for about a week all trains had to arrive and depart via the Down platform.

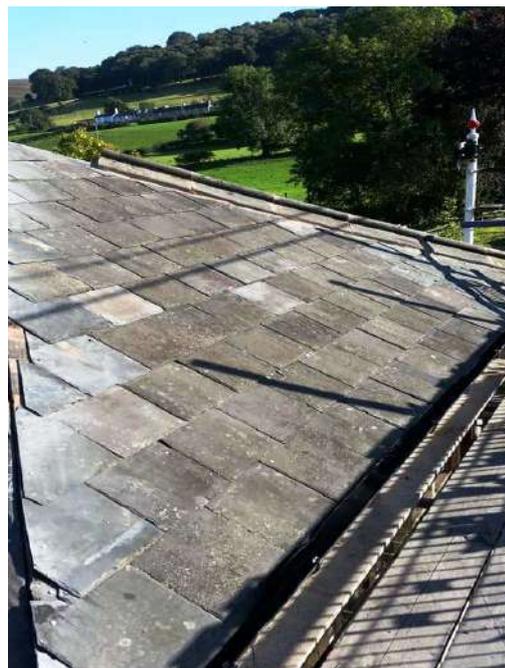
New slates for old looking west across the roof Photo : PC

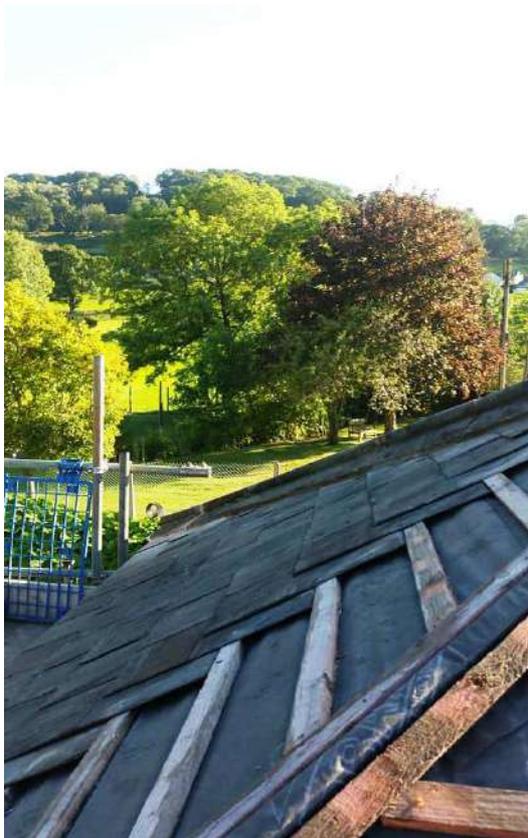
Roof showing battens in place and slates being re-hung Photo : PC

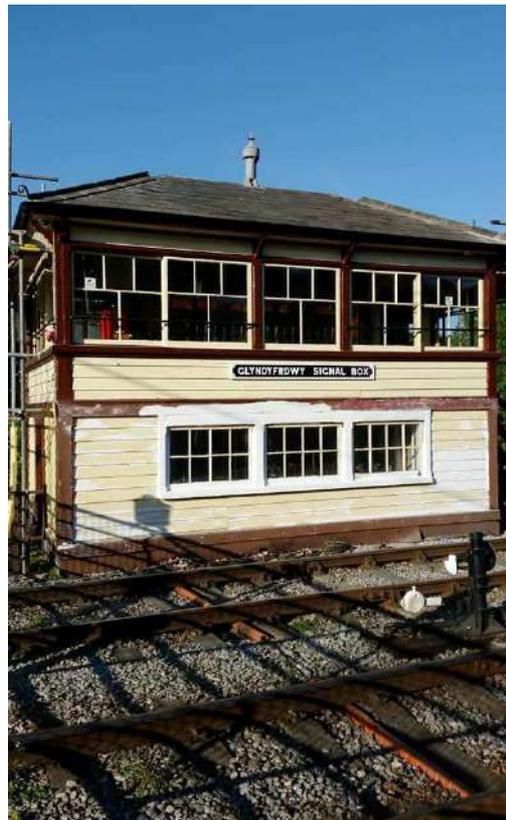
Newly painted top and repaired bottom awaiting paint - smart work!
